Red Line tunnels in Israel – engineering highlights

Eng. S. Liberman & Eng. M. Dvir
Gash Bridge & Buildings Engineering

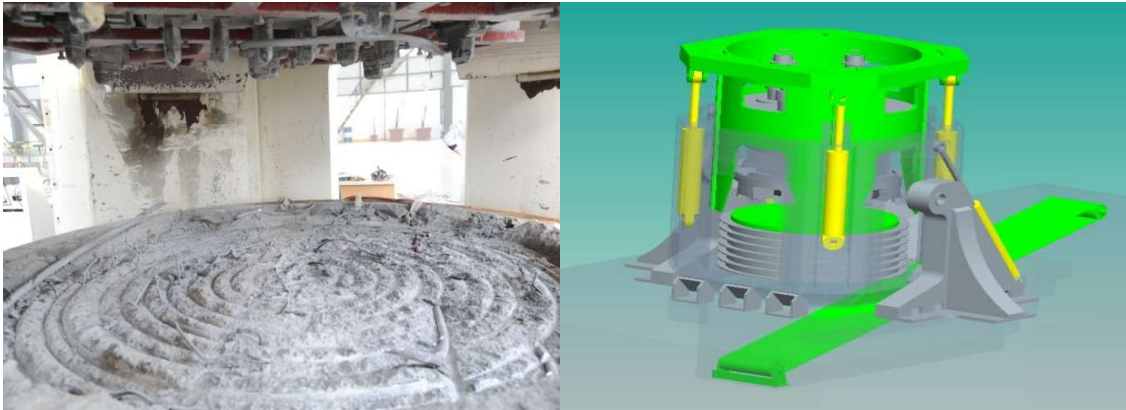
The simulation test took place in China and the proposed cutter was used to cut reinforced concrete as shown in figure 3. The simulation test allowed the following conclusions to be reached:

- Using either disc cutters or drag bits it is possible to cut reinforced concrete piles.
- Discs are very efficient in cutting but the length of the cut rebars is not uniform. The length of rebars after cutting with drag bits is more uniform

Figure 3 – Reinforced concrete, cutting simulation equipment

It was recommended to operate at an excavation speed of 3 to 5 mm/min and a rotation speed of 1 to 1.3 radian/min. The concept is that low excavation speed combined with a high rotation velocity produces fewer disturbances and a smaller length of cut reinforcement.

Another recommendation was to add more quantities of foam and bentonite slurry in order to reduce the cutter head temperature and increase tool's lubrication.

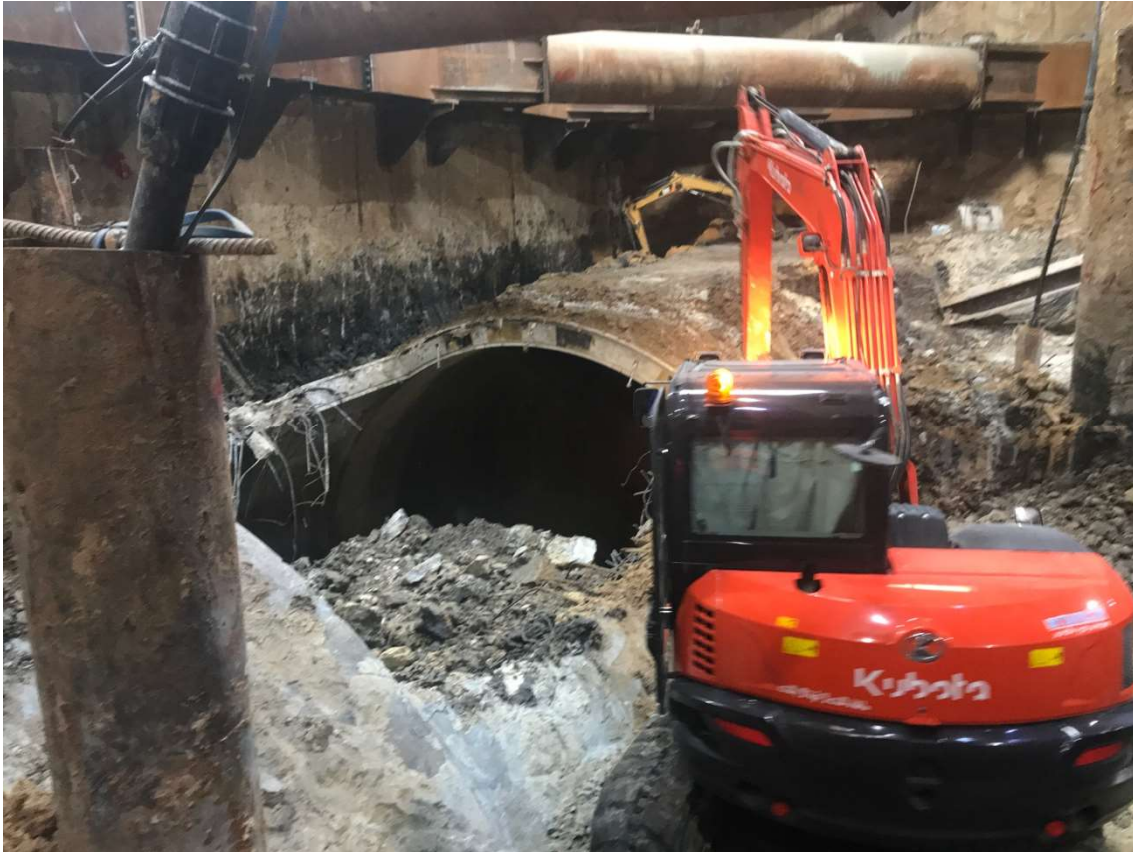
Figure 5– Demolishing one of the tunnels at Shaul Hamelech Station

For this reason, the tunnel antecedent methodology was proposed by the Contractor and approved by the Client. In this case the TBM crosses through the stations after all the external shaft diaphragm walls were cast, or at least partially cast. The excavation of the stations was

performed after the TBM crossing and the tunnel segments inside the stations were demolished. (See Fig. 5)

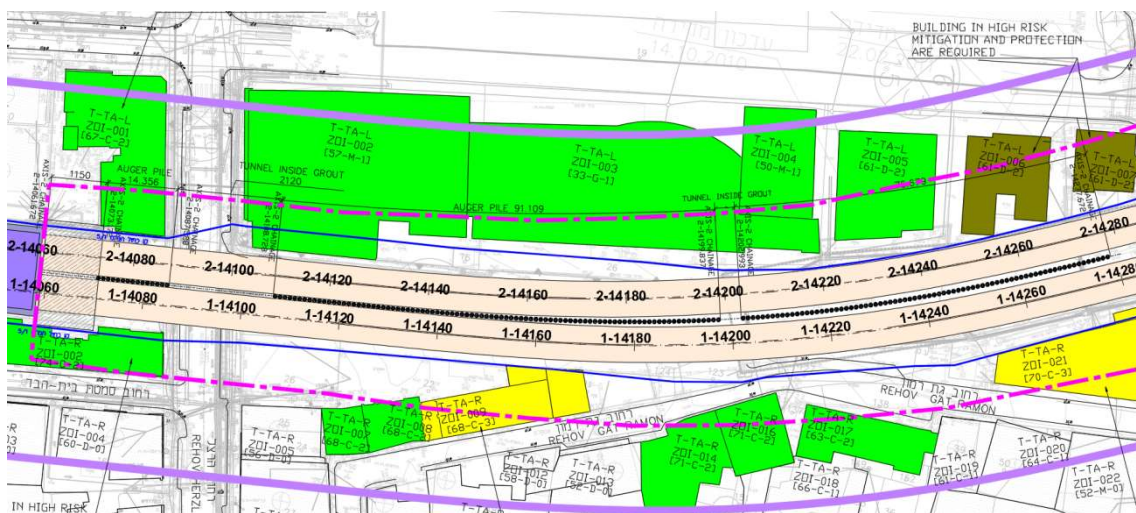
Fig. 7 Section with tunnels in close proximity

At the Herzl launching shaft, the net distance between the tunnels is only 0.8 meters, and the close proximity continues for 220 meters between chainage 14+060 to 14+280. In this alignment section, the minimum overburden is approximately 6.5 meters (at Herzl launching shaft) and the maximum 10.75 meters.

Due to the close proximity of the tunnels, special mitigation measures were implemented including construction of a wall of concrete piles of 0.8 meter diameter and 1.0 m spacing between the tunnels. In some places this solution of pile walls was not adequate due to existing utilities that were not possible to relocate. Instead of pile walls, it was necessary to inject grout from the first tunnel, before the crossing of the second one. The permeation grouting was performed using small dimension equipment in order to allow the continuation of the tunnel works.
